## Varnish Solutions for Lubrication Systems in Gas Turbines

### GAS TURBINE FAILURES

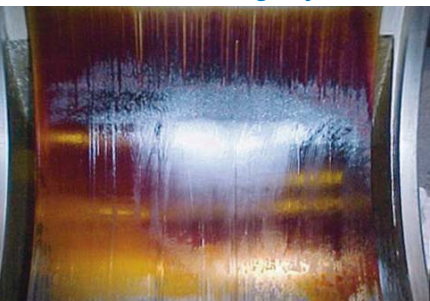
Varnished bearing surface
